# Mission Possible: Fitting Highly Distorted Post-LASIK Ectatic Corneas s/p Intacts with Impression-based and HOA-corrected Scleral Lenses

Sharon Qiu OD MS, Edward Boshnick OD FAAO

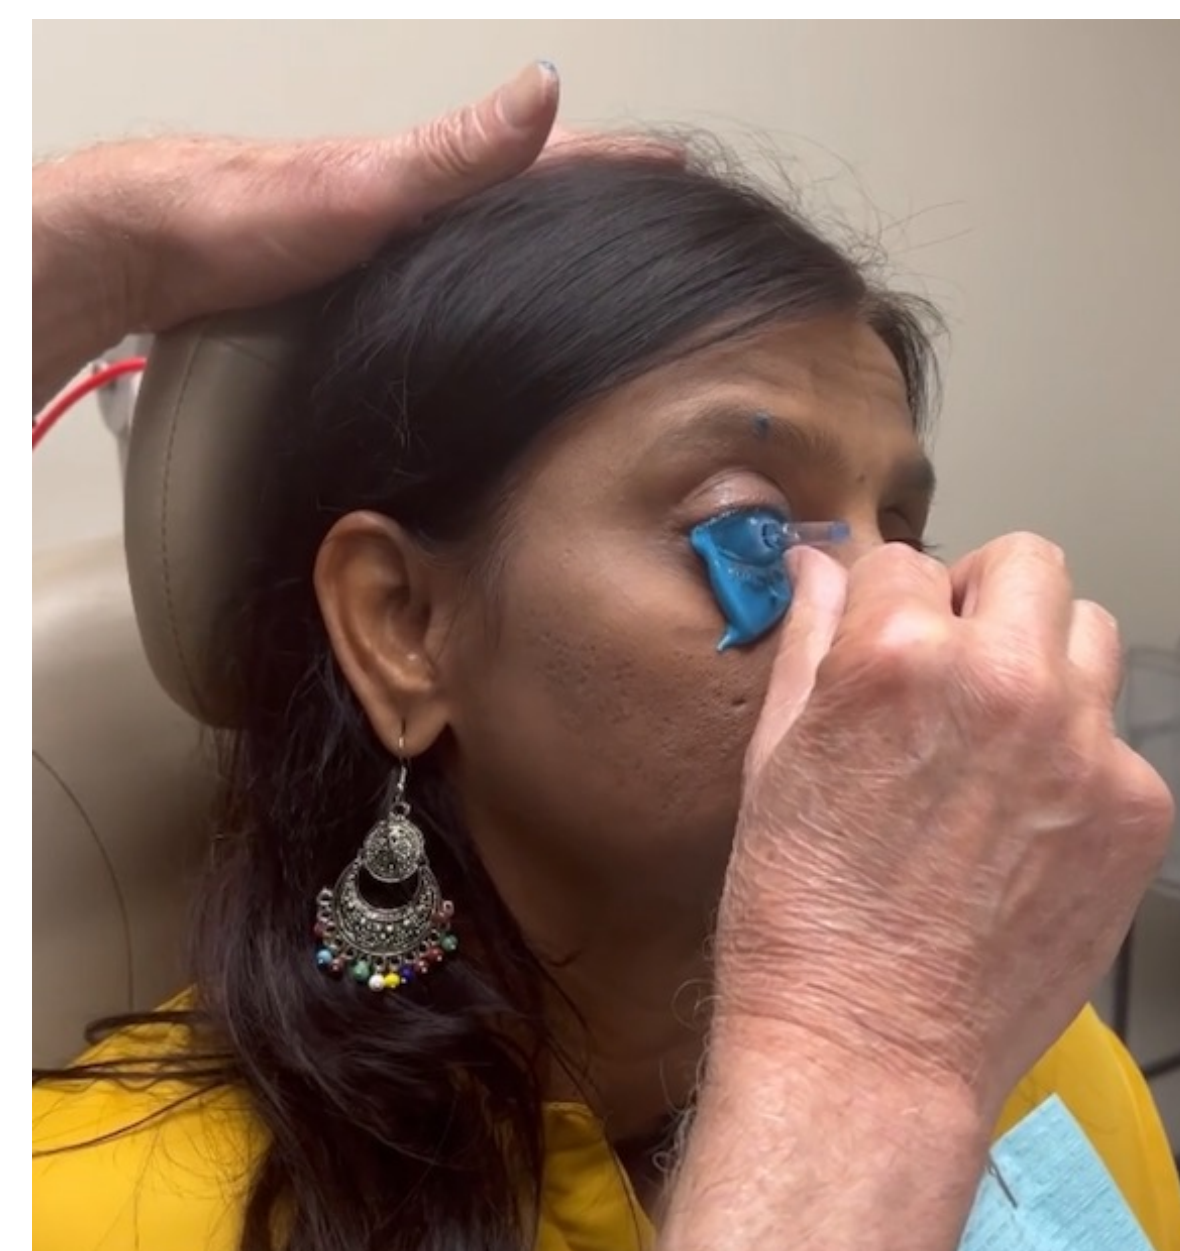
**Figure 5:** Taking an impression of the right eye to design an EyePrint Prosthetics scleral lens

- **Chief complaints:** blurred vision OU in glasses, constantly seeing halos and starbursts:
- **Scleral lens fitting:** EyePrint Prosthetics (EPP) scleral lenses with HOA correction (Figure 5 and 6)

- Initially unsuccessful with conventional scleral lens designs, due to constant edge awareness
  - Eventually, the patient was fitted with **EyePrint Prosthetics (EPP)** scleral lenses: this impression-based technology mapped out the details of the corneal and scleral surfaces and provided a precise fit upon first dispense.
